Invited Paper**ASPECTS OF THE INITIAL AND RECOVERY PHASES OF THE RADIOLOGICAL ACCIDENT IN GOIÂNIA, BRAZIL**

J.J. ROZENTAL, C.E. DE ALMEIDA,
A.H. MENDONÇA
Comissão Nacional de Energia Nuclear,
Rio de Janeiro,
Brazil

ASPECTS OF THE INITIAL AND RECOVERY PHASES OF THE RADIOLOGICAL ACCIDENT IN GOIÂNIA, BRAZIL.

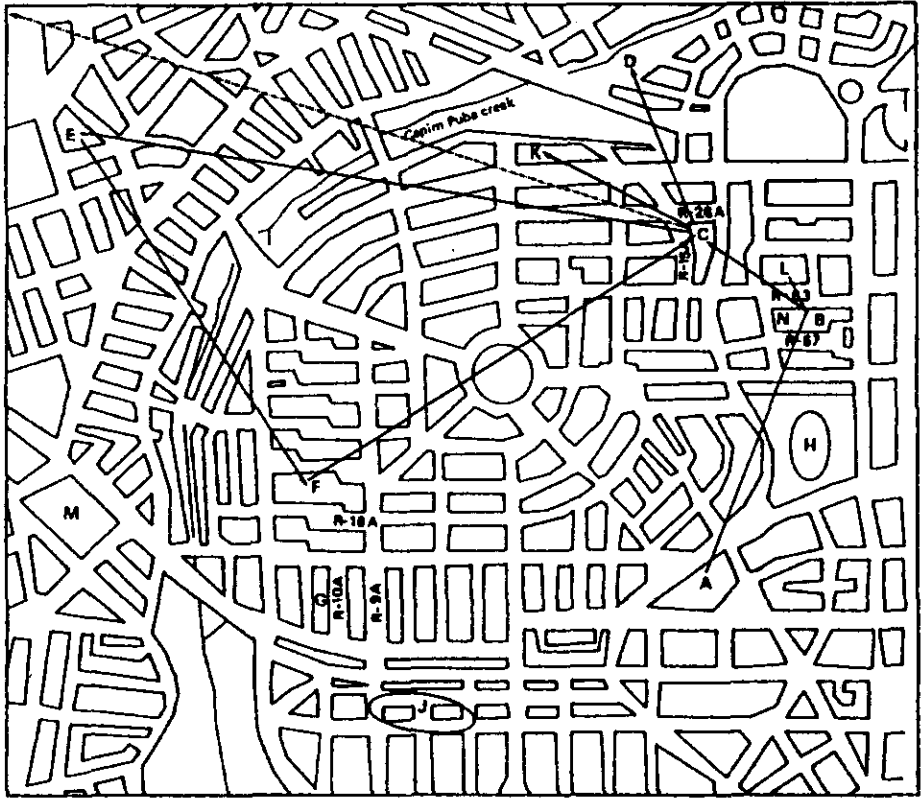
FIG. 1. Principal sites of contamination.

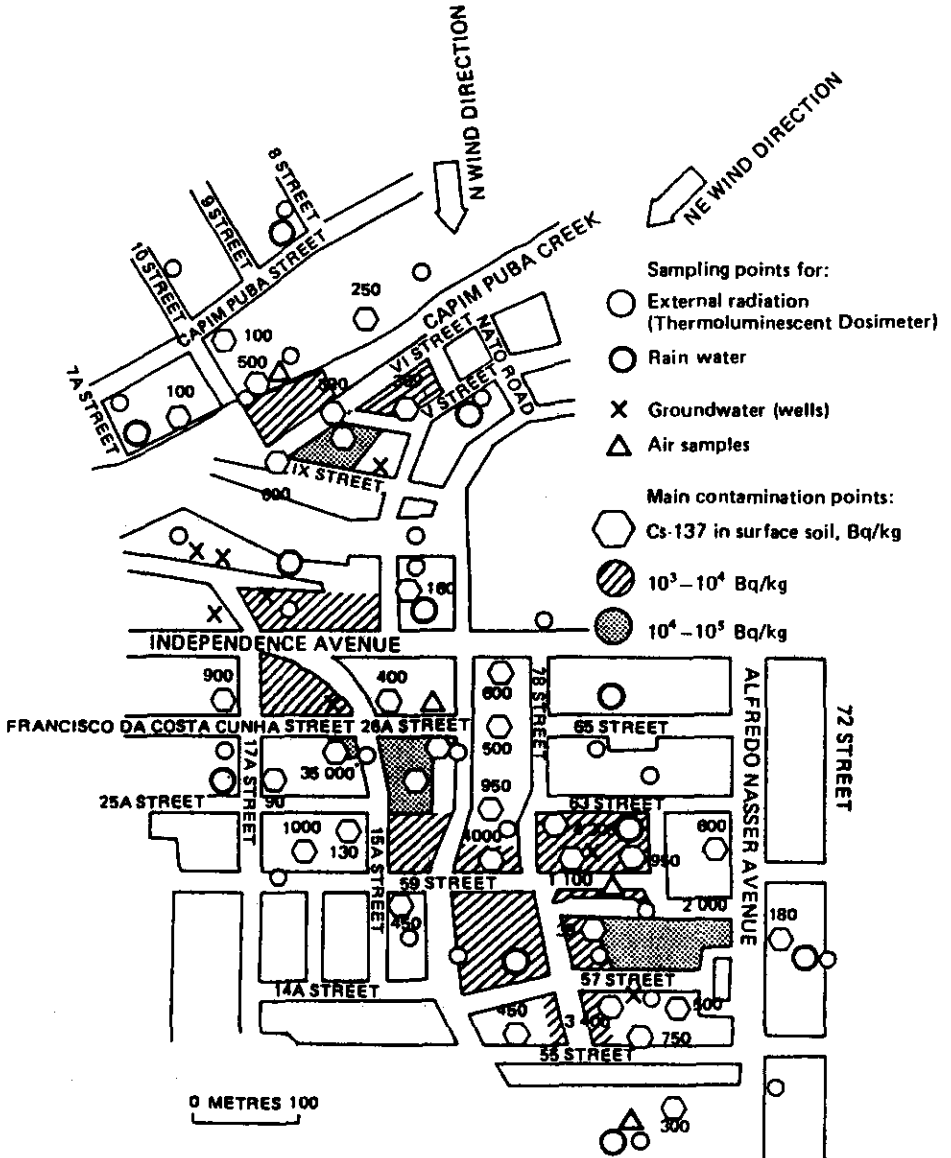
FIG. 2. Principal sites of contamination and sampling points.

Seven main foci of contamination were immediately identified and the respective areas isolated. The radiological survey in one of the foci is shown in Fig. 2.

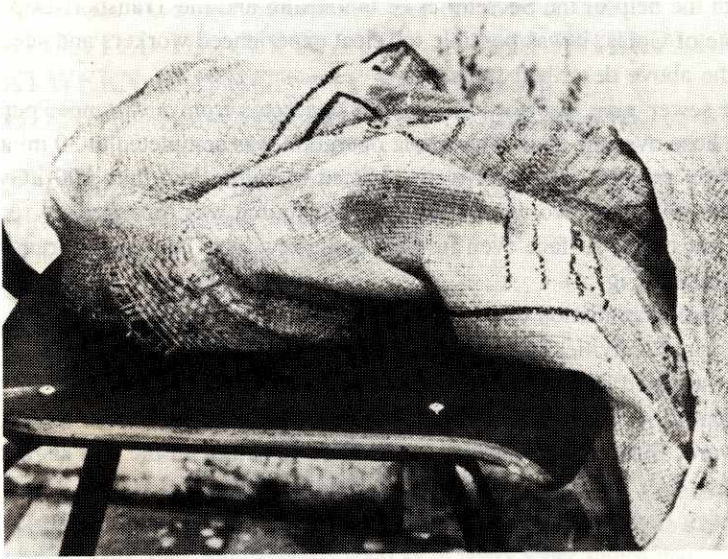
Because of the high exposure rates in the neighbourhood of the Public Hygiene Control building — occasioned by the ^{137}Cs source contained in the metal part that had been brought there previously — it was determined that the part should be shielded with maximum urgency.

The values measured on this occasion were higher than 10 Sv/h near the surface and about 0.4 Sv/h one metre from the source. On 1987-10-1, in conjunction

FIG. 3. The chair after removal from the office. The dose rate at the surface of the cloth bag was 10 Gy/h, and at a distance of one metre 0.4 Gy/h.

The best solution thought of at the time was to place a concrete sewer pipe over the chair, with the help of a truck, generally used for civil engineering purposes, equipped with a crane. Some difficulties had to be overcome during this operation, for instance:

- the chair was behind a 2 metre wall and very close to it (less than 20 cm away)
- the pipe oscillated when lifted
- the pipe had to be moved downwards slowly to prevent the chair from turning over.

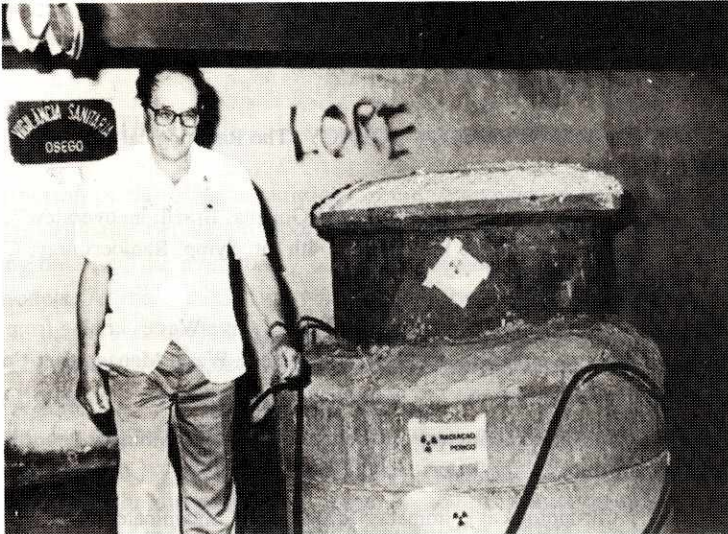
FIG. 4. The shielded source and chair. The operation was completed in 30 minutes.

with the Departments of Health and of Transport of the State of Goiás, steps were taken to shield the source of ^{137}Cs with concrete.
